Manhole Inspection Summary

Manhole # S13EE1001MH

Insp Date: **1/26/09 1:10 PM**

Location Address: **4052 PARK HEIGHTS**

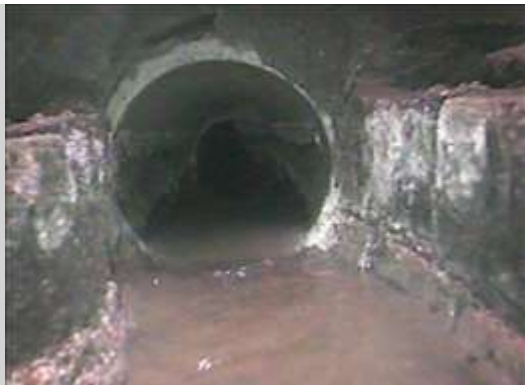
3 O'Clock Inflow

Pipe Height: (in.) Direct
Pipe Material: **Clay** ☐ Pipe Lined
Invert Depth: **8.45** (ft.) Flow Characteristics: **Slow**
Deposits: ☒ None ☐ Mud ☐ **Sludge** ☐ Debris ☐ Grease
Silt Depth: (in.) Deposits Extent:
Infiltration: **None** Pipe Seal Cond: **Sound**
